FINAL REPORT

Desktop Fault Evaluation Study

Fremont BART Station Parking Lots (TOD)

Fremont, California

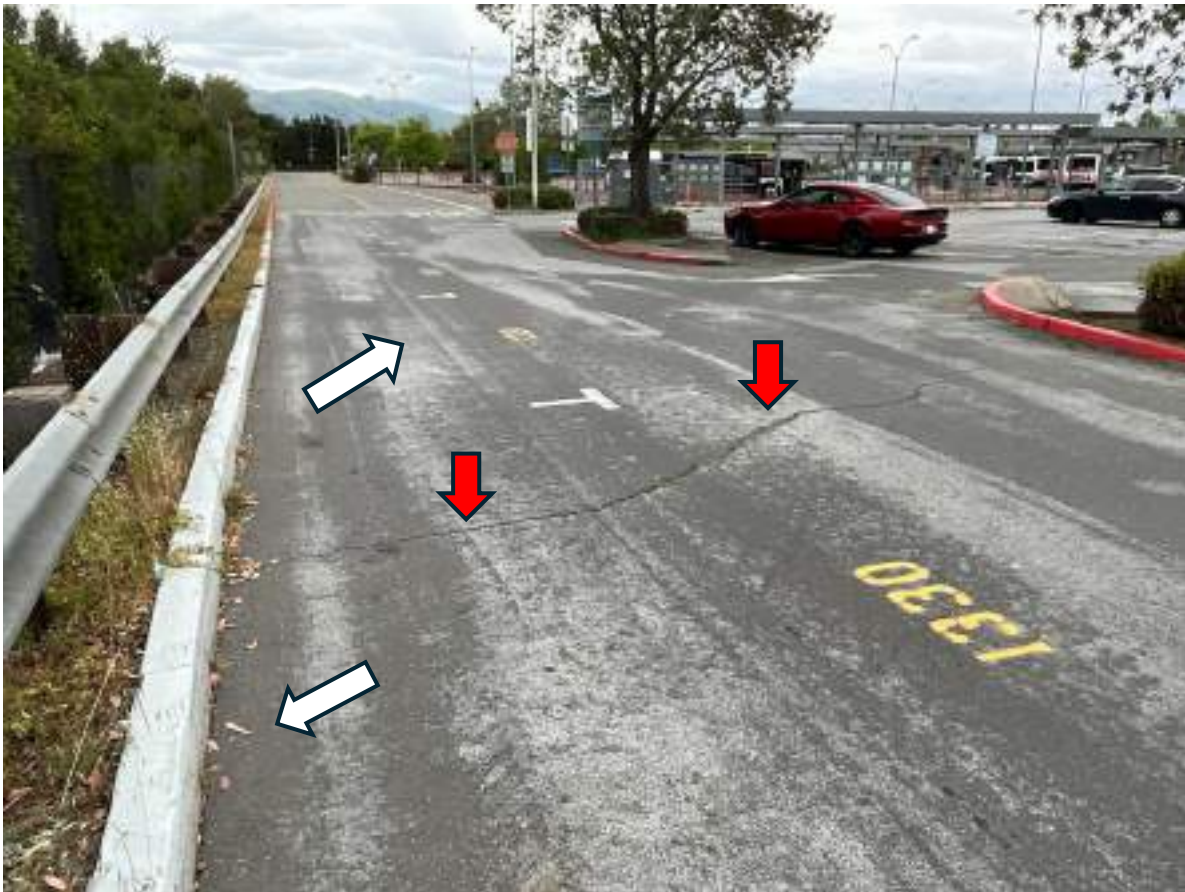
Evidence of active fault creep included right-laterally offset concrete curb and en echelon pavement cracking within parking lot H (Photos 1 and 2; see Figure 1 for location).

Photo 1: View to south along eastern access road within Parking Lot H. Note offset curb (white arrows) and cracking in pavement (red arrows).

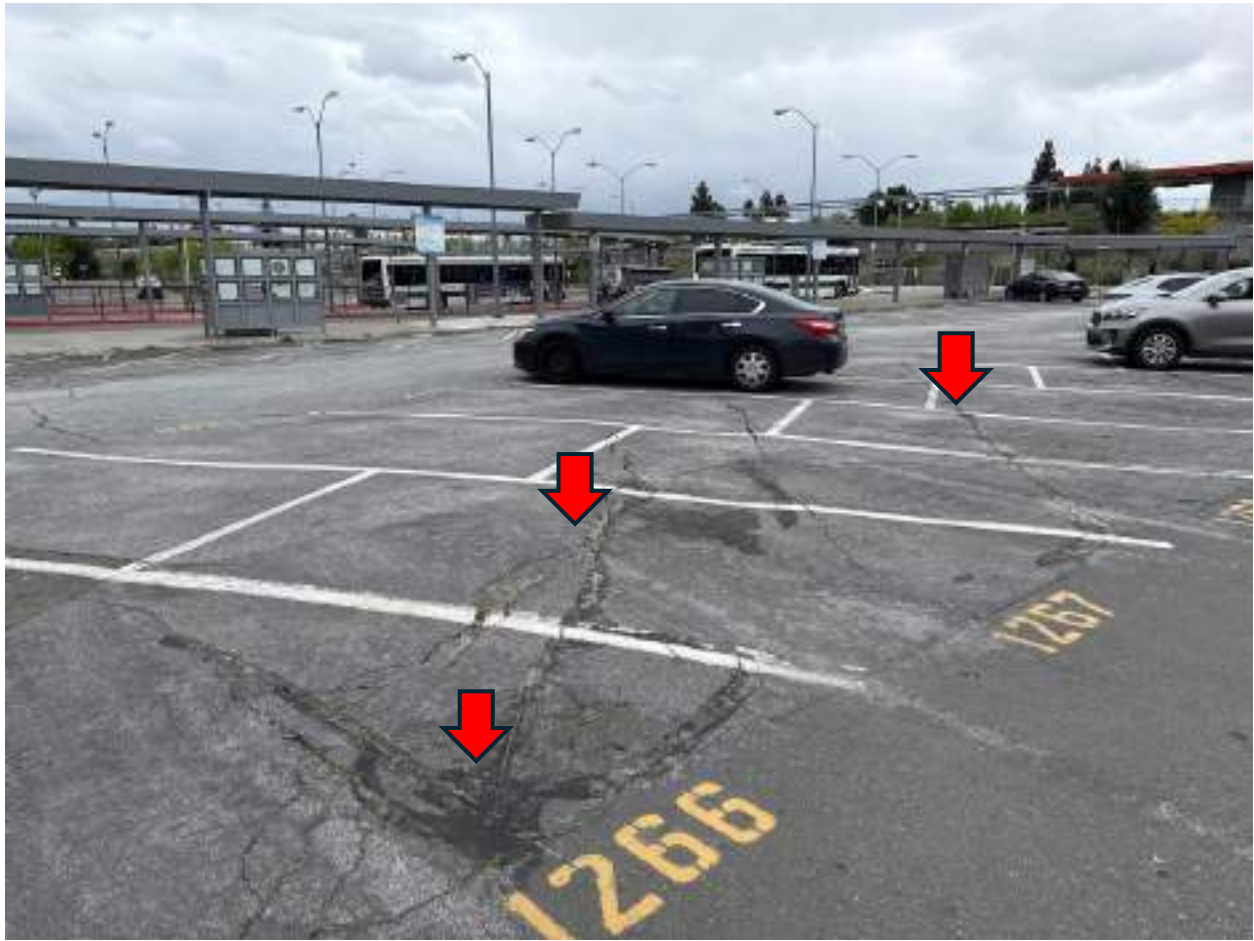
Photo 2: View to southwest of pavement cracking (red arrows) within Parking Lot H coincident with mapped creeping trace of the Hayward fault (Lienkaemper, 1992).
