FINAL REPORT

Desktop Fault Evaluation Study (Revision 1)

Fremont BART Station Parking Lots (TOD)

Fremont, California

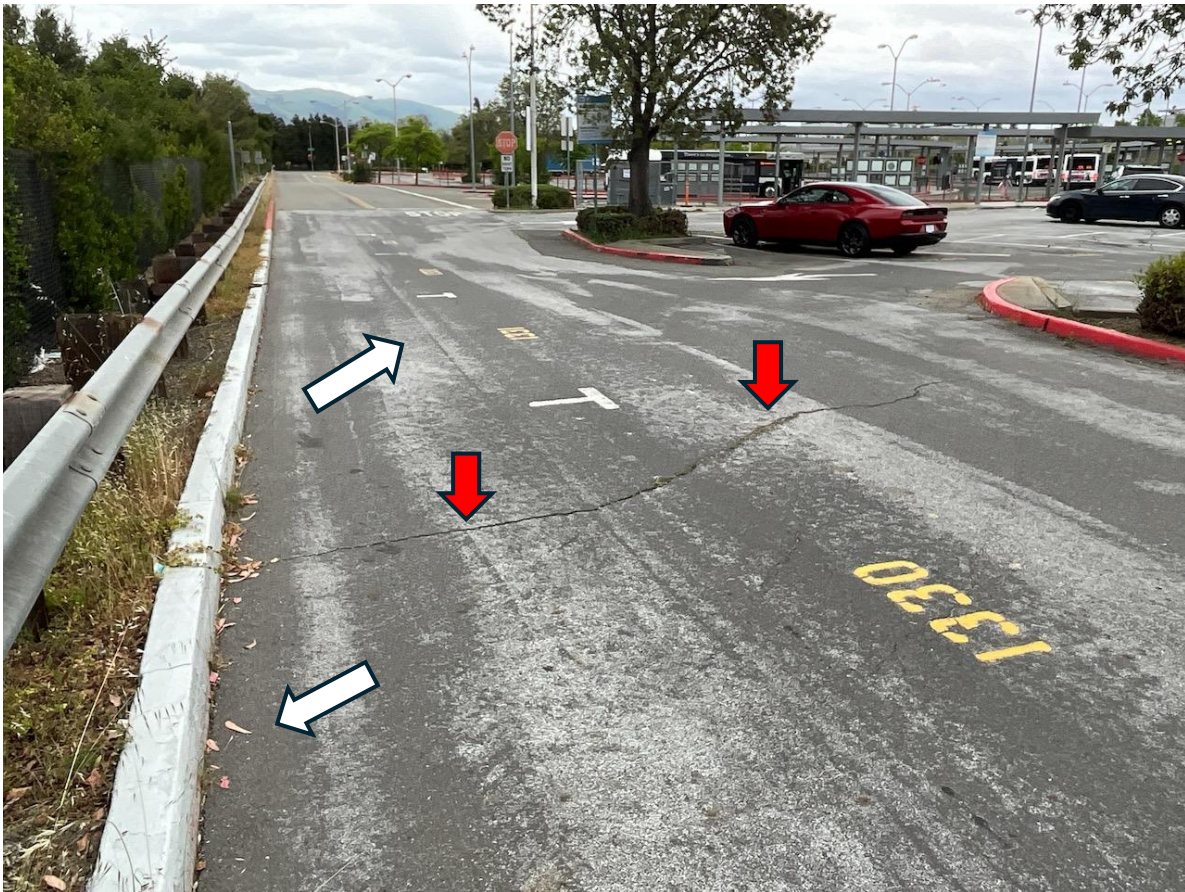
Evidence of active fault creep included right-laterally offset concrete curb and en echelon pavement cracking within parking lot H (Photos 1 and 2; see Figure 1 for location).

Photo 1: View to south along eastern access road within Parking Lot H. Note offset curb (white arrows) and cracking in pavement (red arrows).

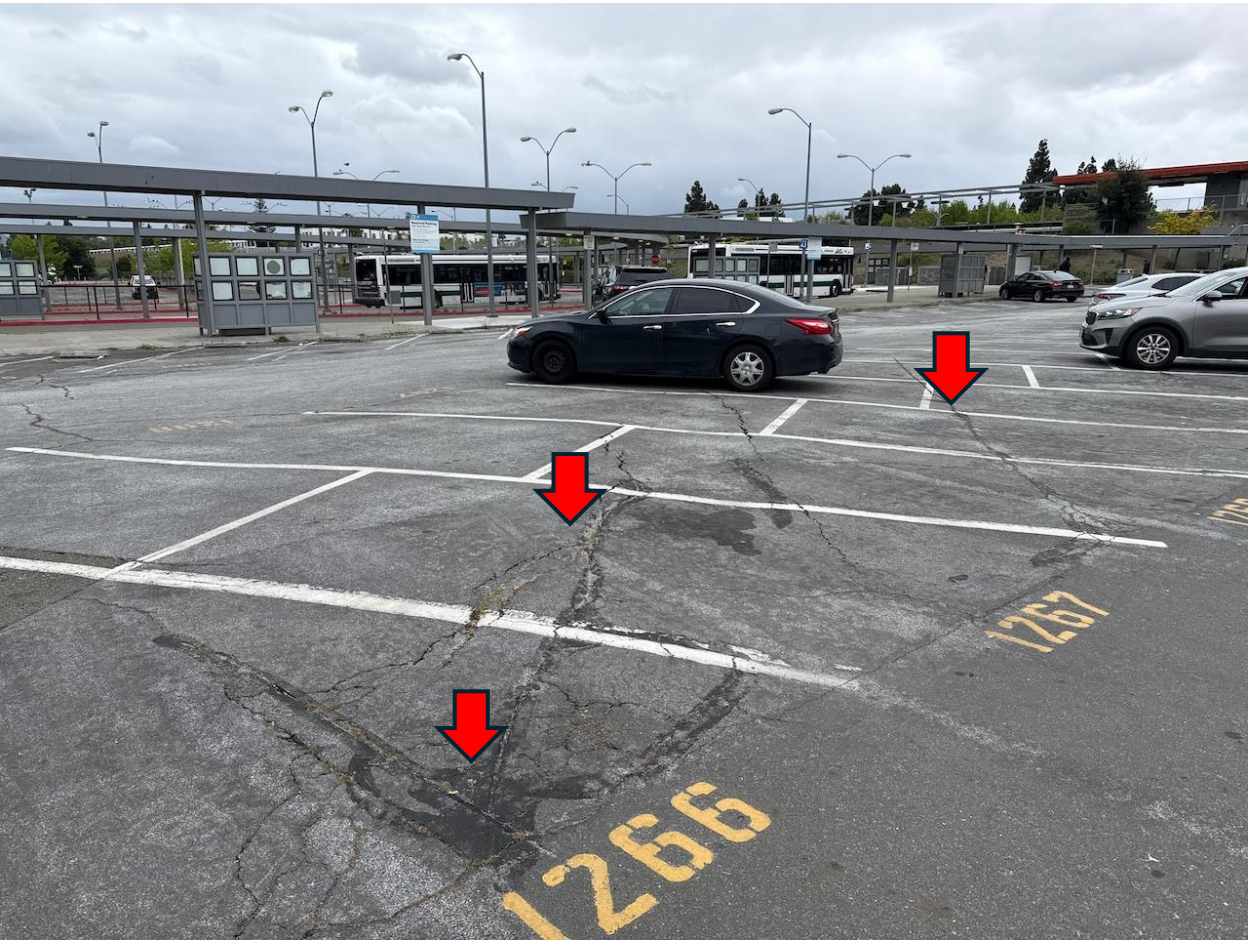
Photo 2: View to southwest of pavement cracking (red arrows) within Parking Lot H coincident with mapped creeping trace of the Hayward fault (Lienkaemper, 1992).

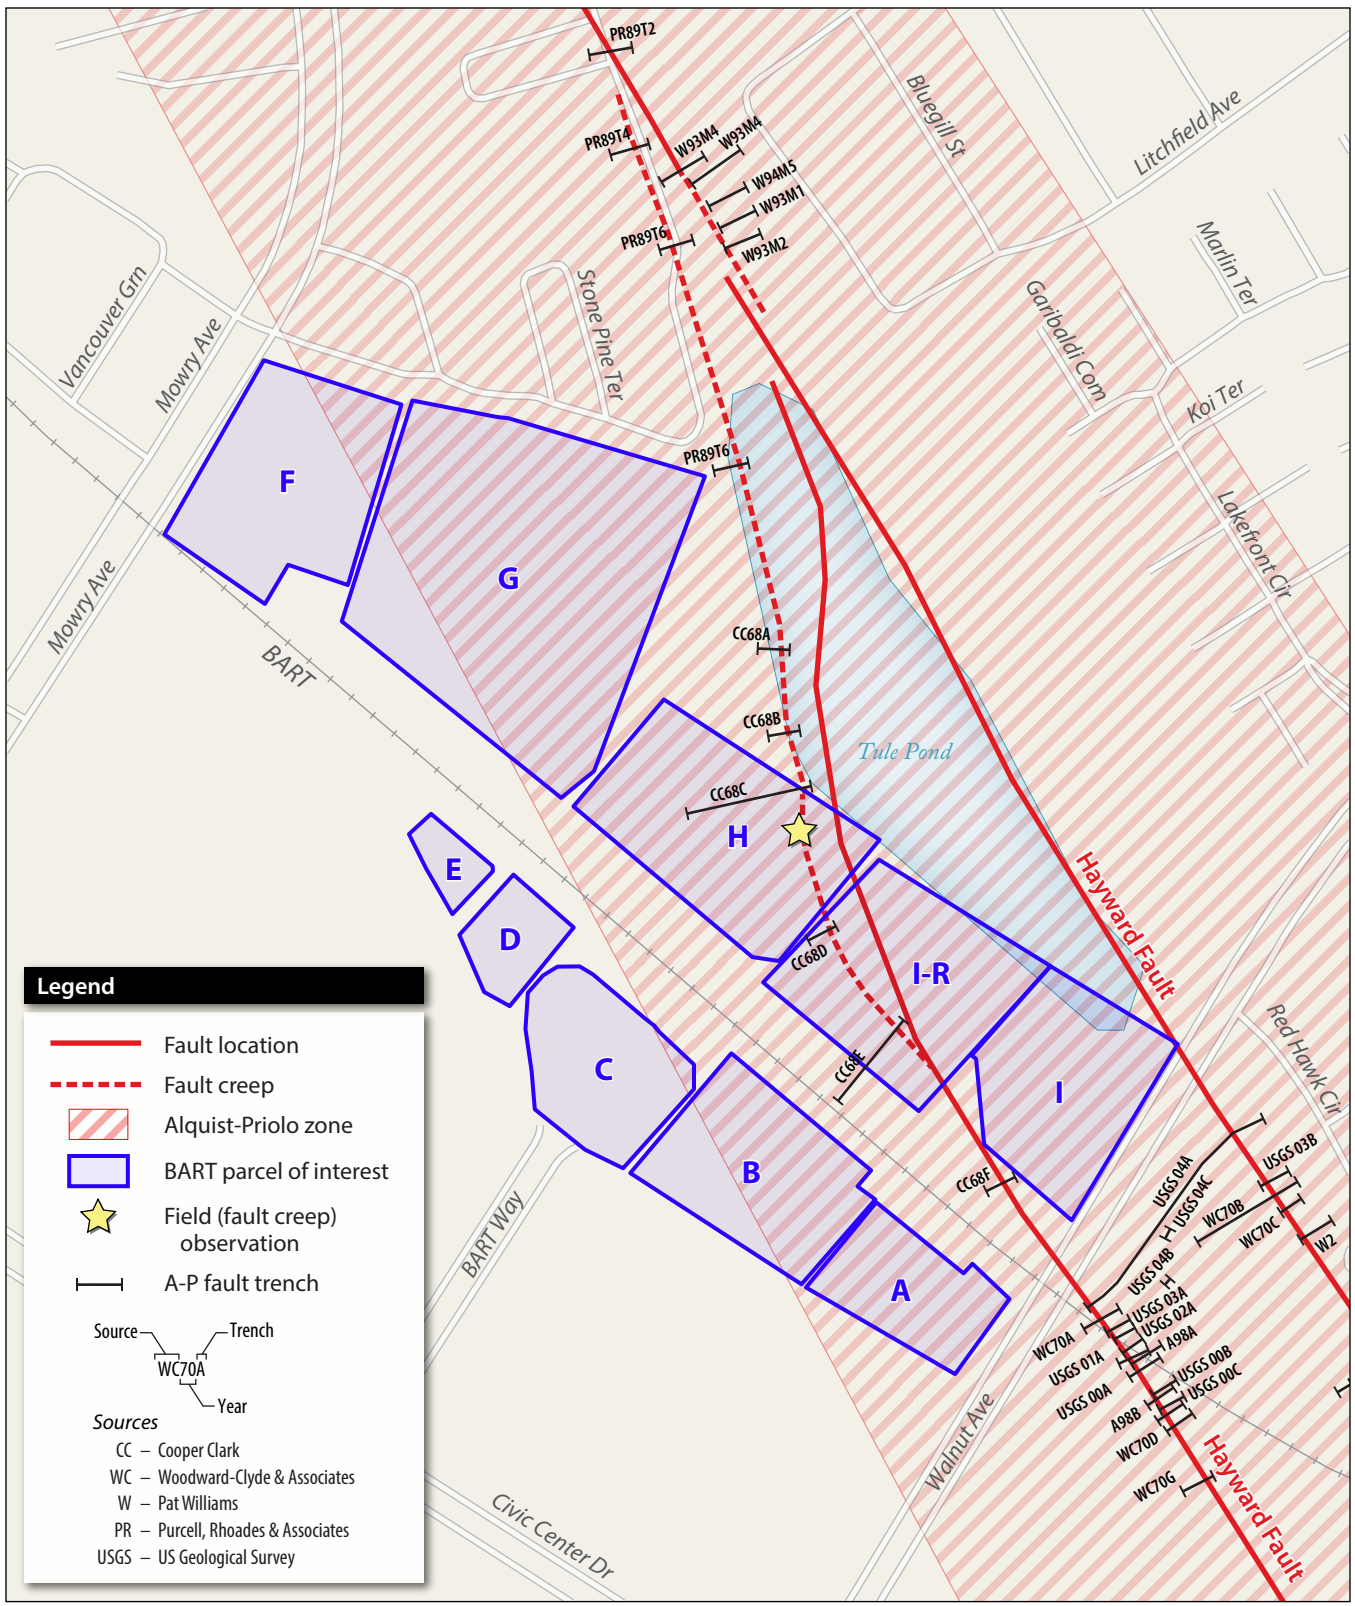
FREMONT BART FAULT RUPTURE HAZARD EVALUATION
Figure 1. Project Location Map Showing Active Traces of Hayward Fault

At Walnut Avenue, these two primary strands are parallel and about 350 ft (107 m) apart and have an average orientation of about N32°W (Figure 1). About 1,750 ft (530 m) north of Walnut Avenue, the two primary fault strands merge into a single fault trace and form the northern end of Tule Pond. South of Walnut Avenue, the eastern fault strand dies out, and the Tule Pond depression rises gradually to a linear hill directly southeast of Stevenson Boulevard. The former Fremont Civic Center occupies the crest of this fault-bounded "pressure ridge".

We conclude that active strands of the Hayward fault extend beneath lots H, I-R, and I. In addition, the soils underlying lots I and I-R likely are younger and less stable than those underlying the lots located west of the fault zone. Finally, it is also considered strongly likely that secondary faults and/or shears may be encountered beneath these lots during trenching that would preclude use of much or all of the lots for construction of structures with human occupancy. Given the likely fault-related constraints identified for this desktop study, lots I and I-R are not recommended for future study, and therefore potential development. In contrast, although the eastern corner of lot H likely is crossed by the creeping western strand of the fault, most of the western portion lot should be located west of any estimated setback ('no occupied building area') from the fault and therefore likely available for development (e.g. Figure 2). Finally, underground utilities that extend across these lots may experience ongoing fault creep and more significant deformation during future large ground-rupturing earthquakes on the Hayward fault.
